The study was conducted under DA Project 4A762730AT42, Design, Construction and Operations Technology for Cold Regions, Task D, Cold Regions Design and Construction, Work Unit 015, Infrared Inspection of New Roofs Prior to Acceptance.

**MOISTURE DETECTION IN ROOFS WITH CELLULAR PLASTIC
INSULATION - WEST POINT, NEW YORK, AND MANCHESTER, NEW HAMPSHIRE**

Charles J. Korhonen and Barry A. Coutermarsh

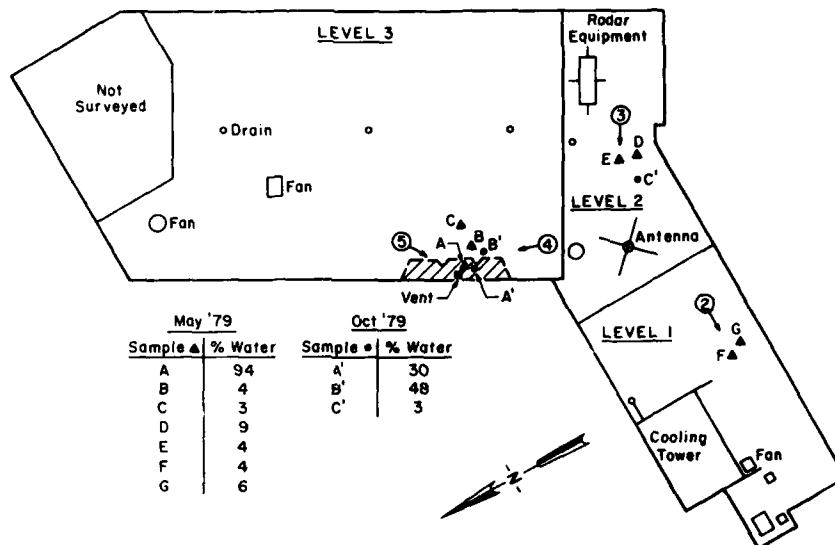
Figure 1. Plan view sketch of Building 753, West Point. For this and all other building sketches in this report, a circled number with an arrow indicates the location and viewing direction of a particular figure.

During the May and October surveys the thermal image of each level of the roof of Building 753 (Fig. 1) was mottled (i.e. with thermally light and dark areas blending into one another). By scraping the gravel cover and taking samples F and G (Fig. 2) in May we determined that the mottling was caused by varying gravel thicknesses and not wet insulation. Thick layers of gravel store more solar heat and remain warmer longer than thin gravel layers. Figure 2c, although mottled, does not have as pronounced mottling as Figure 2a, indicating less solar effect in October. The two black areas in Figure 2c were caused by patches at F and G.

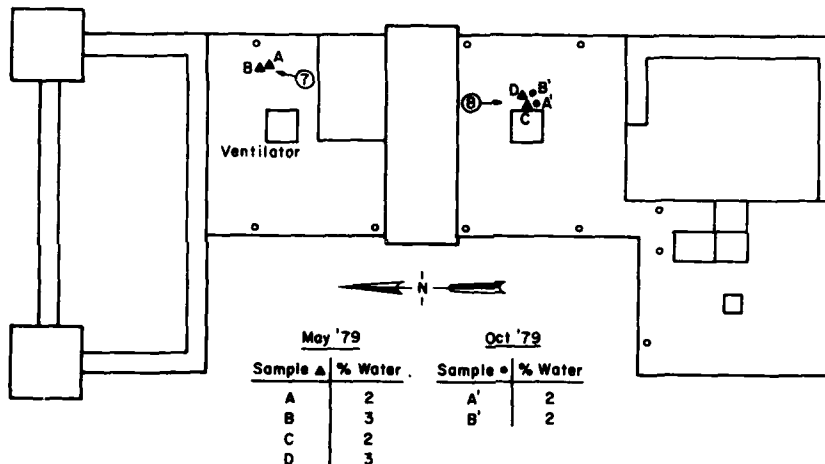
Figure 6. Plan view of Building 751.

thermal mottling on most of this roof was related to varying gravel thickness, but mottling was also observed in a few areas where the gravel thickness was uniform. Representative samples A and B (Fig. 7) contained only 2 and 3% water, respectively; therefore the thermal mottling was not considered moisture-related. Since both A and B had identical membrane thicknesses (3/8 in.), we expect that slight differences in the bitumen flood coat thickness caused the slight thermal mottling. Since the gravel and a portion of the flood coat are normally spudded off before coring, no measurements were obtained to verify this contention.

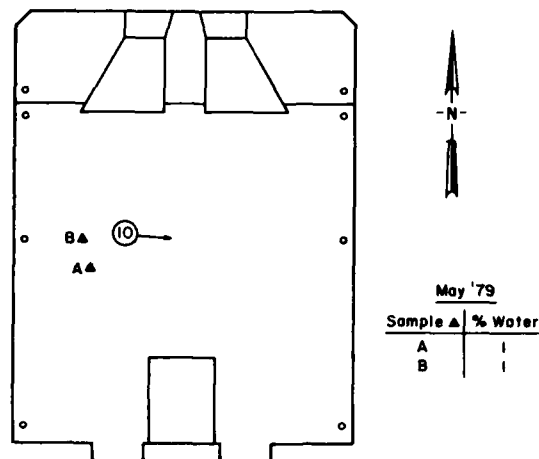
Figure 9. Plan view of Building 745A.

A plan view of the roof of Building 745A is shown in Figure 9. The thermal mottling, to which we had by now become accustomed, was present on this roof and could be attributed to varying gravel (or bitumen) thicknesses and not moisture. We did note that the mottling was somewhat fainter by the time we surveyed this roof. Figure 10 shows that the northern half of this roof was thermally brighter than the southern half, but that samples A and B taken from the southern and northern half, respectively, were dry. We were unable to gain access to the space below the roof but speculate that this thermal pattern was caused by room to room temperature differences.

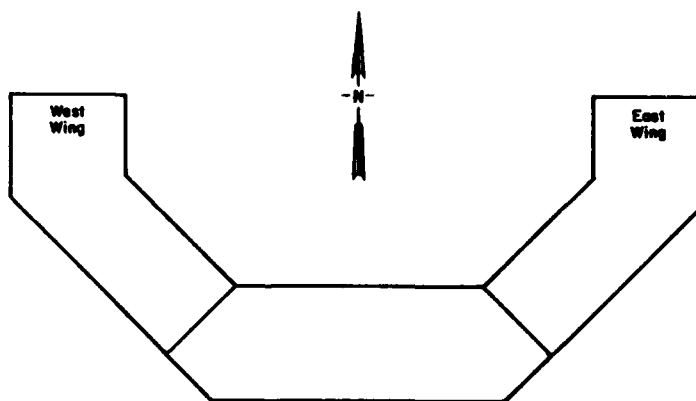
Figure 11. Section A, Building 667.

of the west and east wings of section A, which are shown in plan view in Figure 11. The west wing roof membrane was installed prior to December 1977 and the east wing membrane was installed prior to May 1978. Due to some unfinished work, the warranty for the roofs of these wings did not commence until December 1978.

Several thermally bright areas were found on each wing. Core samples showed that they were areas of wet insulation. Most of this moisture can probably be traced to flashing problems. The counter-flashing shown in Figure 12 was not installed until six months after the roof membrane was finished. When the flashing was finally installed, the sealant and bond-breaker rod between the flashing and the wall began to fall out and had to

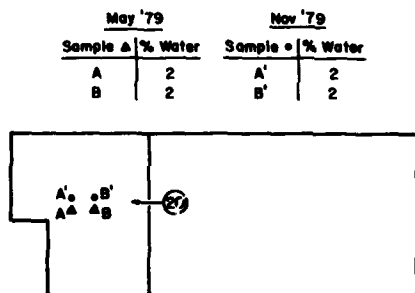
Figure 19. Plan view of the Motor Pool Garage at Grenier Field.

A plan view of the roof of the Motor Pool Garage is shown in Figure 19. Thermally this roof was mottled during both the May and November surveys (Fig. 20). Samples A and B taken in May and samples A' and B' taken in November were dry, which convinced us that this mottling was not moisture-related. The bright areas in the Figure 20 thermograms correspond to areas of thicker gravel. Since all core samples were dry and no other thermal anomalies were detected, we feel that this roof contains no wet insulation.

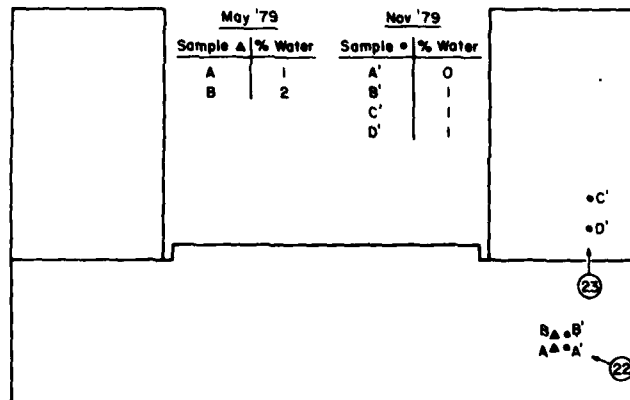
Figure 21. Plan view of the Main Building at Grenier Field.

A plan view of the Main Building's roof is shown in Figure 21. Varying gravel thicknesses created the thermal mottling detected on this
